The Occidental Chemical Center

Niagara Falls, New York, 1980, Cannon Design Inc.

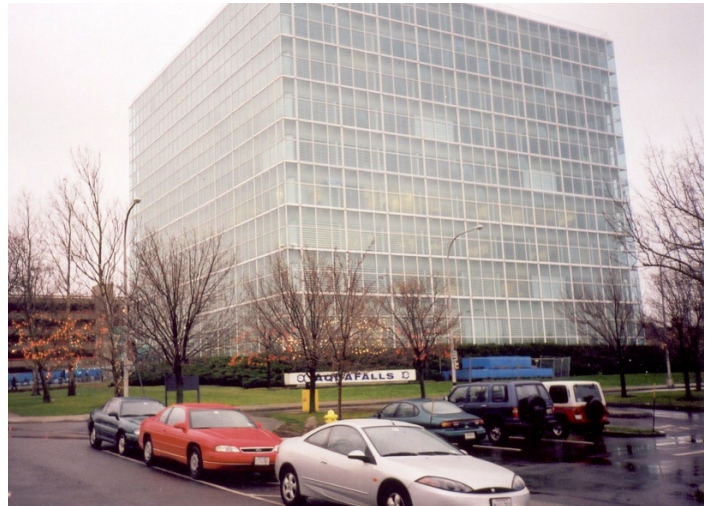
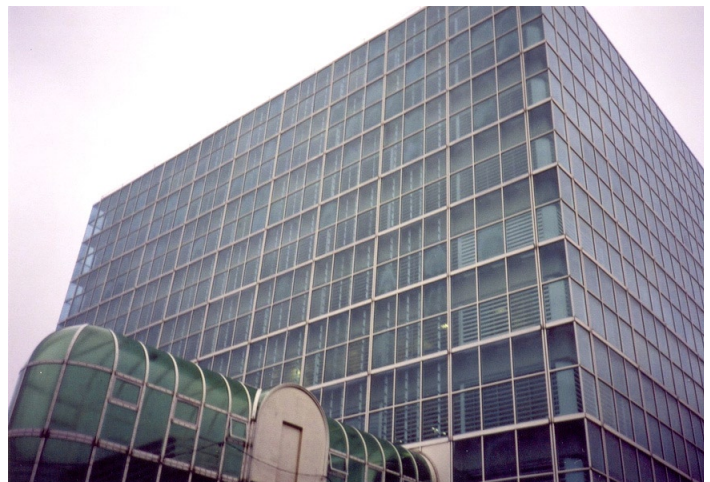
The Hooker Building West facade from Niagara Gorge parking lot and detail of the Southeast corner with pedestrian bridge that formerly connected to the parkade.

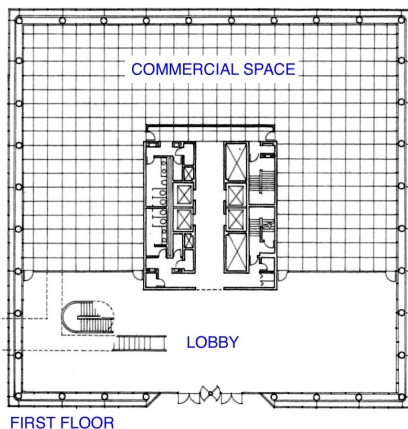
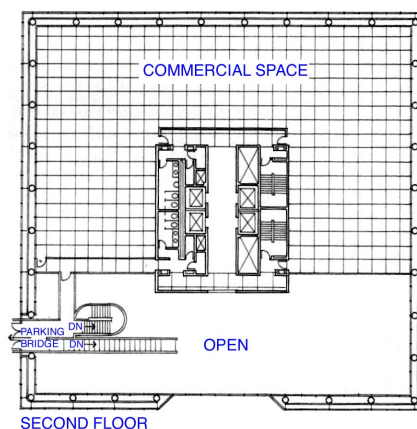
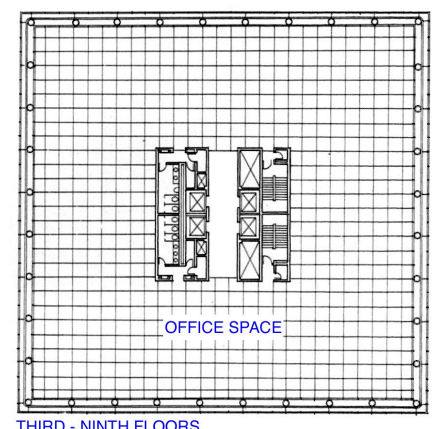
Above: the current North Facade. Below: floor plans showing the original entrance cut into the East facade; the only place in the building where the otherwise uniform facade is interrupted.

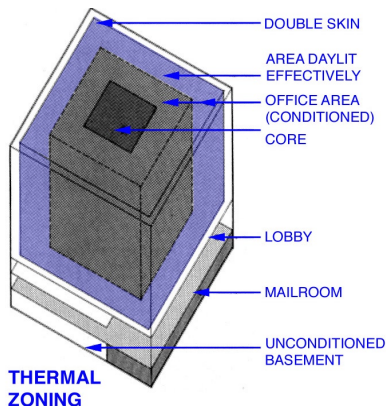
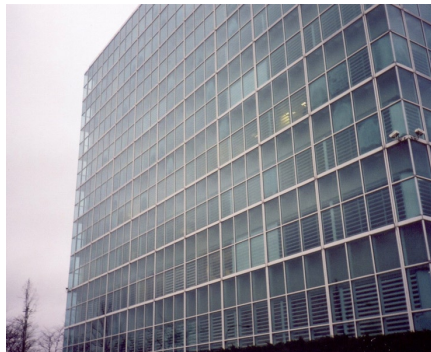
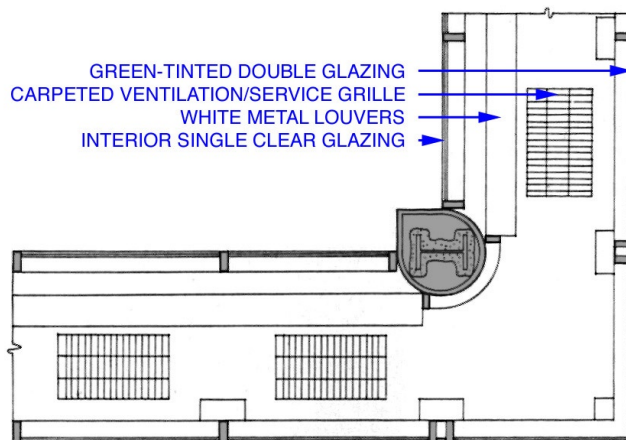
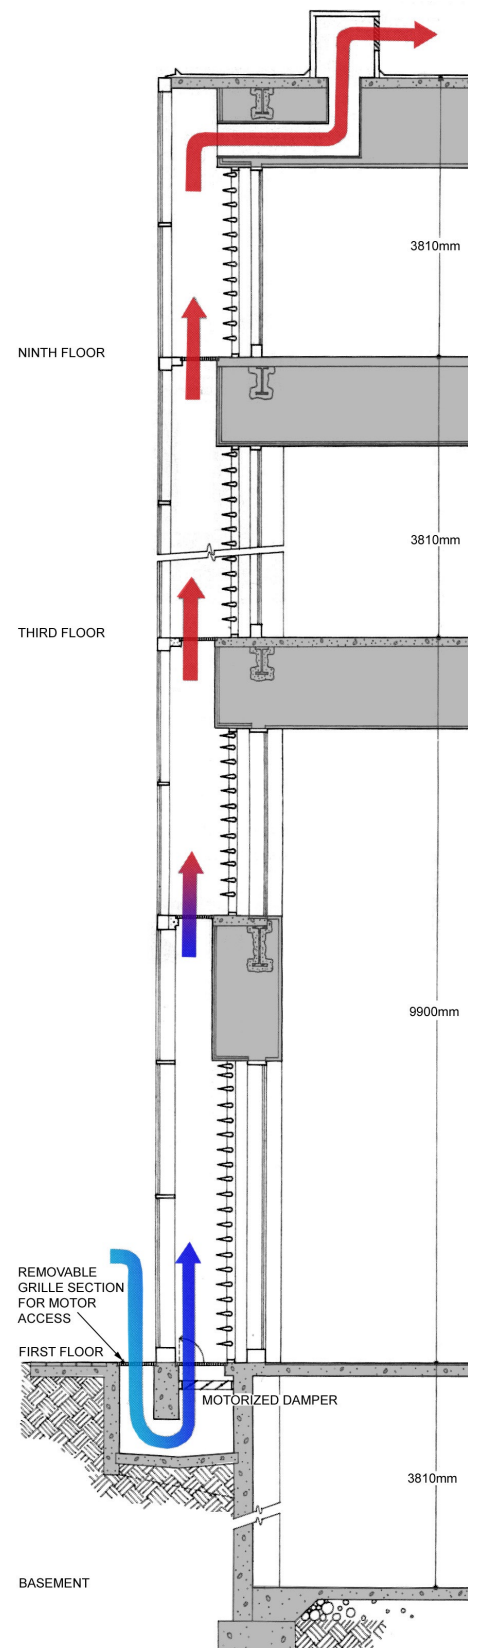
The Hooker Building Southern facade is pictured here along with the thermal zoning design schematic showing both areas with daylighting and the differing HVAC zones, along with both vertical and horizontal sections through the buffer facade.

The building envelope is comprised of two layers of green-tinted insulating glass that allow for 80% solar penetration as the exterior skin, a 1200mm air space containing hollow metal, air-foil shaped, white louvers - spanning fifteen feet and vertically spaced eight inches a part - with service grilles (originally covered with beige carpeting to give the appearance that the floor continued from within the offices through to the exterior glass), and one layer of clear glass as the interior skin. As a means of being economical, the architects made sure that all the components of the façade -

save the control and monitoring equipment - were “off the shelf.” The louvers in the air cavity are controlled by an “intelligent” light sensor system that responds according to weather, time of day and season. The sensors are placed in pairs to discount mullion shadows and a delay response cancels the effect of passing clouds. The façade is separated into four different “zones” according to the North, South, East and West exposures so that each of the four walls may respond according to the amount of daylight being admitted according to the particular time of day. The louvers are capable of fully closing as means of providing additional “insulation” during the winter months.
