When Design Kills: A Case for Safety in Tall Buildings

Terri Meyer Boake

Professor, University of Waterloo

**Tall
Excellence**
Seeking the Ideal in Vertical Urbanism

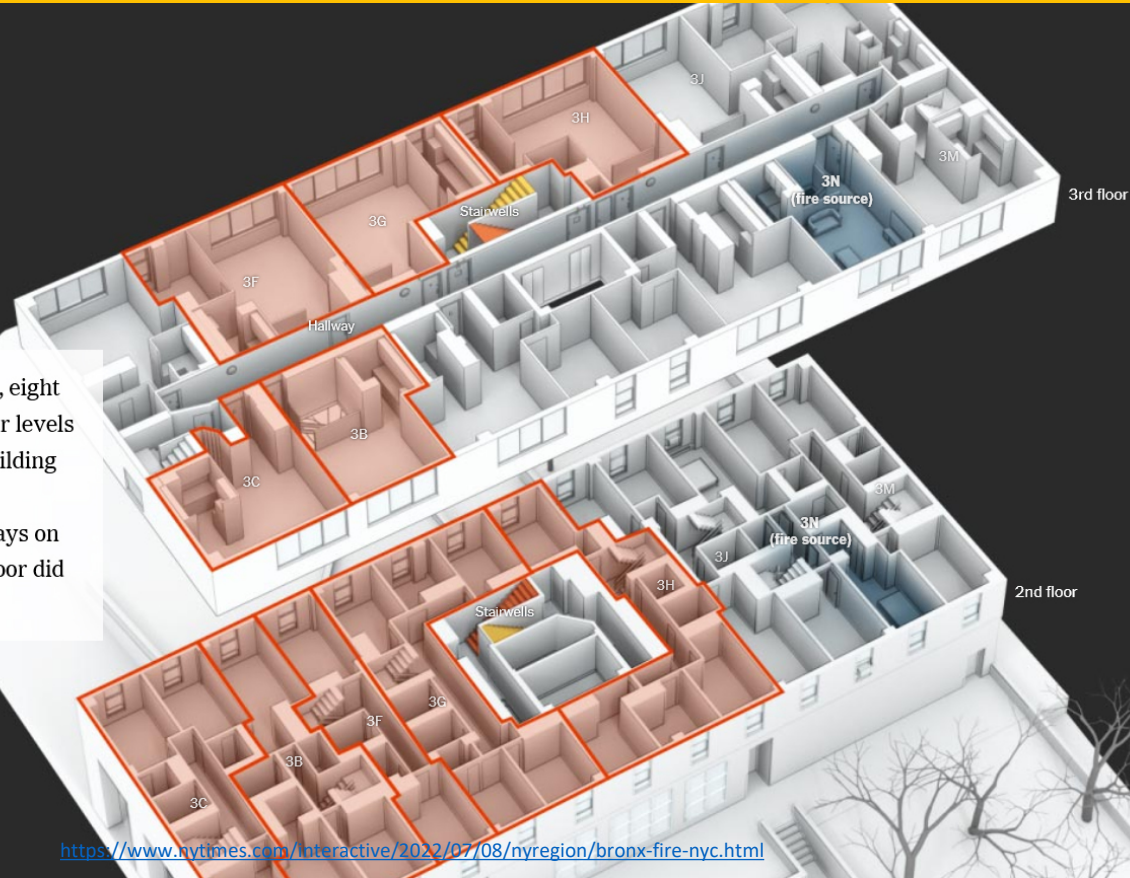
Scissor stair, 2 storey units, dead end corridors, confusion

On the third floor, for example, eight units were duplexes with lower levels on the second floor. But the building stairwells and elevators were accessible only through hallways on the third floor — the second floor did not have hallways.

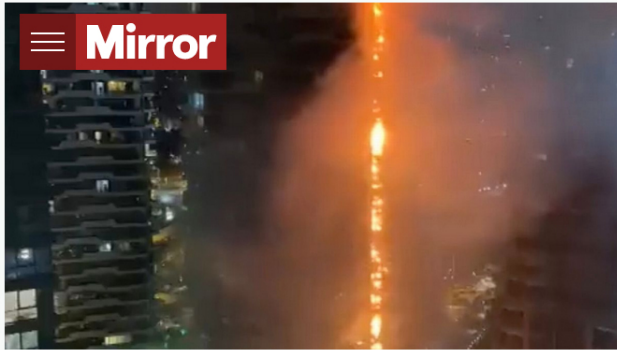
Istanbul Tower Fire – 15 October 2022

The fire tore through the tower – the second blaze to hit that part of the Turkish capital in a week (Image: Twitter)

Of note is that the fire “tore up” the corner of the building as it spread.

This points to building design as contributing to the problem.

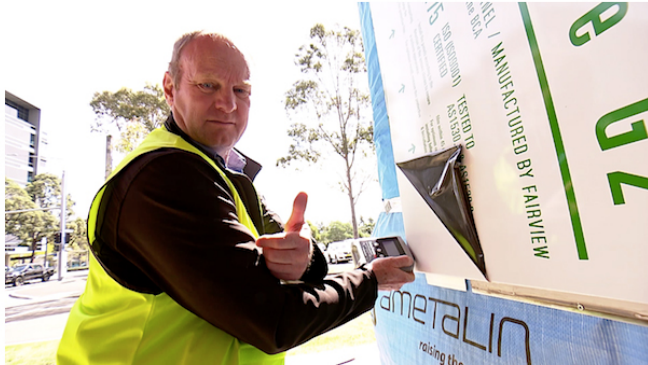
DataTraceID, originally developed to prevent and detect counterfeiting and prove product authenticity, contains a luminescent inorganic marker, which provides a light signature that can be read by DataDot's spectrometer.

Military-grade spectrometer technology developed by government research agency the CSIRO and Sydney company DataDot Technology has been successfully trialed in a pilot program to accurately identify the origin of safe cladding on building façades. Counterfeit flammable cladding - said to be imported from China, with stickers attached falsely declaring it to be fire resistant - was found in Victoria just last month.
